**INGRESS PROTECTION VENTS  
(IP65, IP66 & IP67)**

TEST CERTIFICATE AND REPORT  
ISSUED BY CSA GROUP  
TESTING UK LIMITED

**Ingress Protection tests on  
Porous PTFE materials  
on behalf of Porex Technologies Ltd**

**Report No: N70055499B**  
Commercially in Confidence

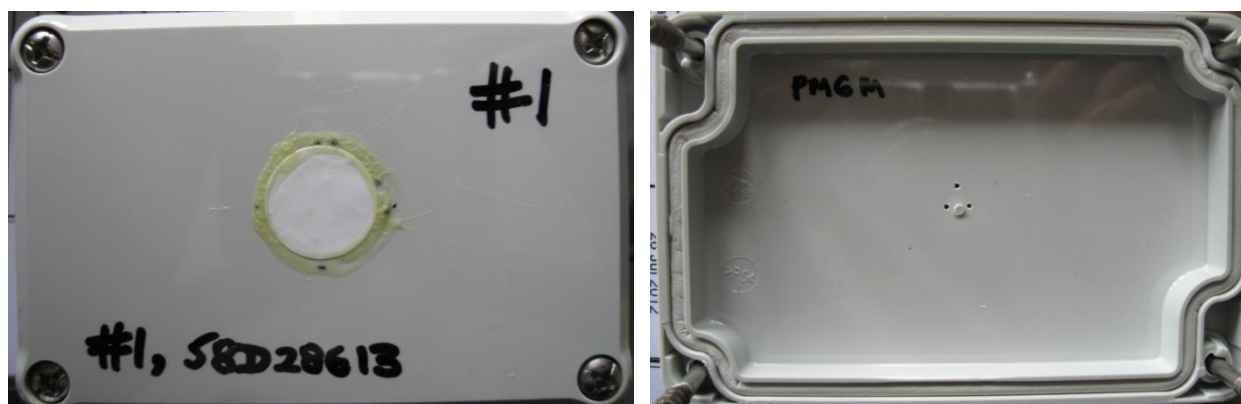
Figure 1 Typical sample

For the purposes of the tests the sample membranes were supplied by the customer attached to test enclosures. The membranes were used to cover a pattern of three holes drilled by the customer in the enclosure wall, the diameter of the holes were 0.8 mm. See Figure 1 for details of a typical sample.

The approximate dimensions of the membranes were 17 mm diameter.

As the apertures were a collection of three 0.8 mm diameter holes, see Figure 1, it was not possible for the 1 mm test wire to puncture the membranes. Additionally there were no visible signs of damage to the membranes.
